AUSTIN AVENUE BRIDGES AT SAN GABRIEL RIVER Condition Assessment and Evaluation

Georgetown, Texas 78626

Final Report

WJE No. 2015.5402

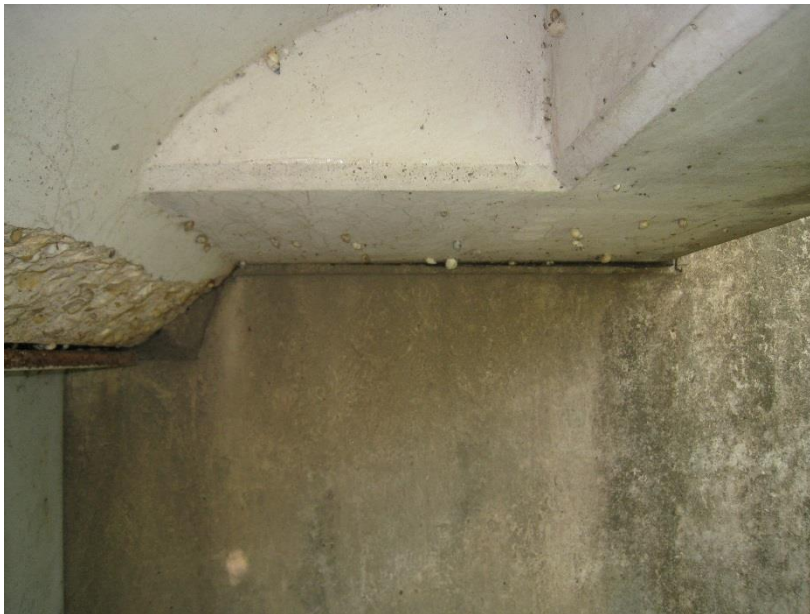
1. The concrete deck had separated from the top of the outermost girder flanges by up to 3/16 inch at the north and south ends of the North Bridge. Form indentations were visible in the abutment back wall behind the deck at each separation, and expansion material between the deck and abutment back wall appeared to be compressed or partially dislodged (Figure 8). Minor surface corrosion was visible on the unpainted outer edges of the girder top flange, but no corrosion was visible at the top surface of the top flange, between the girders and deck (Figure 9). Figure 8 and Figure 9 were taken at the same location at the exterior of the westernmost girder at Abutment 1 of the North Bridge.

Separation of the concrete deck from the top flange of the outermost girders at the ends of the North Bridge was most likely caused by unintended binding between the abutment back walls and the longitudinal ends of the deck. An expansion board was installed between each deck end and abutment back wall, but indentations in the back wall and visible compression of the expansion board near the outer deck edges suggest that the deck is bearing on the abutment walls instead of the girders at these locations. Because the deck is not mechanically anchored to the steel girders below, separation of the deck from the girders may not induce structural distress in either component. The deck does not exhibit apparent cracking or other distress at these locations, other than the spalling of the unreinforced, chamfered haunch edges as discussed earlier, indicating that the condition does not present an immediate structural concern. Furthermore, pack rust typically initiates at unconfined member edges and propagates inward. Lack of corrosion at the top flange exterior edges of the exposed girders suggests that the deck separation is not related to formation of pack rust between the girders and deck. The diaphragm crack indicated in Figure 12 appears to be the result of this lifting of the deck off of the girder top flange as indicated in Figure 8 and Figure 9.

Figure 8. Typical movement at corner of North Bridge (southwest corner shown), with spalling along unreinforced haunch chamfer.

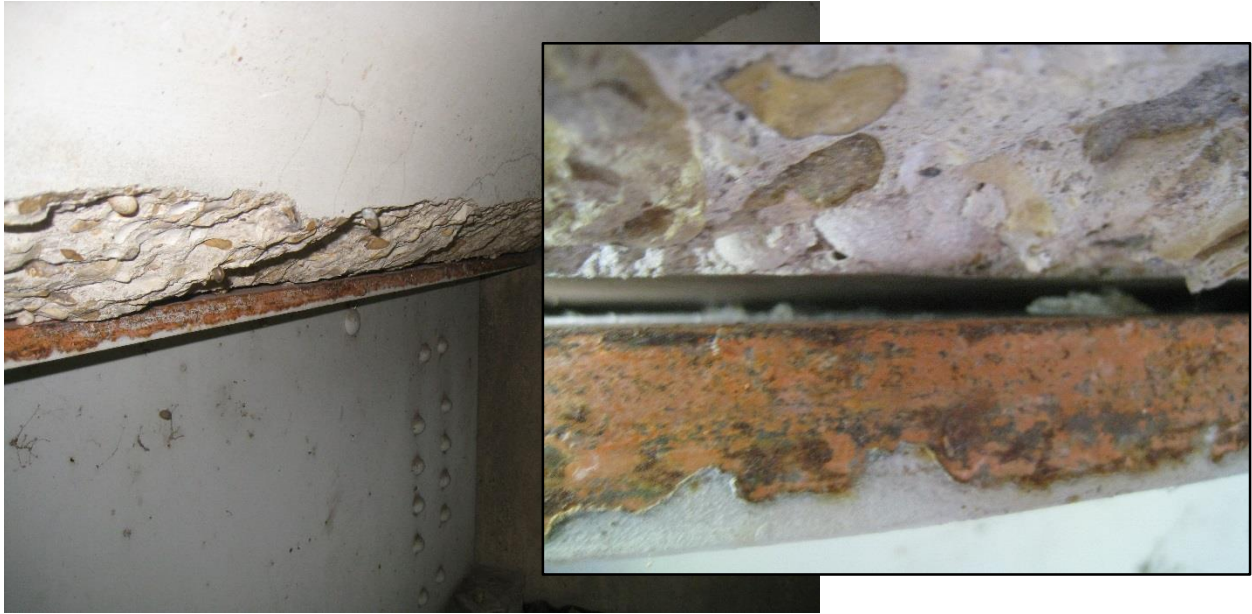
Figure 9. Typical gap at corner of North Bridge (southwest corner shown), with lack of apparent corrosion on girder top flange.

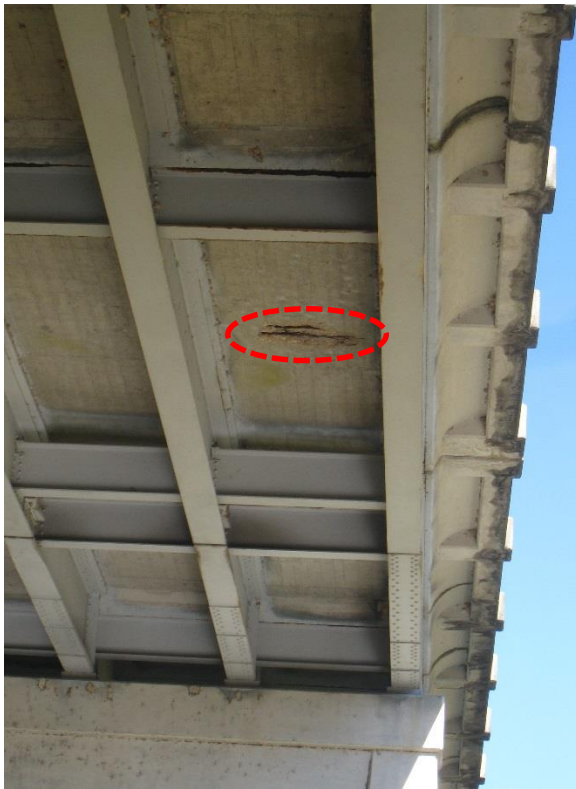
2. Isolated spalls with corroded reinforcement, totaling less than 50 square feet per bridge, were located at slab soffit locations in the North and South Bridges (Figure 10). Reinforcement clear cover at accessible spall locations was measured to be approximately 3/4 inch. The spalls were approximately 24 to 48 inches in diameter and represented less than 1 percent of the slab soffit area. Spall locations appeared random and varied relative to girder, span, or joint location.

Observed delaminations and spalls likely originated at locations with the least concrete cover, other substrate defects such as cracking or other mechanical damage, or areas with locally poorer quality concrete, due to the exterior exposure and effects of carbonation. In general, the spalling and delaminations appear to be relatively small in area and randomly distributed at slab soffit locations. However, the iron oxide formed as a result of corrosion is expansive. Once corrosion of the reinforcement initiates, corrosion continues to propagate until surface damage manifests, which further serves to remove the corrosion protection provided by the concrete. Accordingly, once corrosion becomes visually apparent in concrete structures, corrosion formation at exposed reinforcement typically accelerates.

Figure 10. Typical, isolated deck soffit spall with two exposed, corroded bars (east side of South Bridge Span 3 shown).

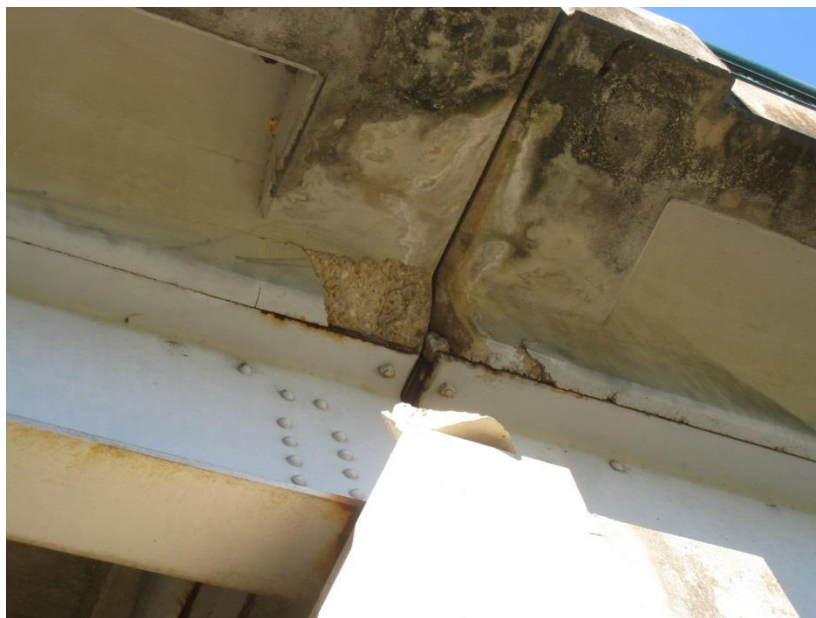
3. Isolated spalls, generally without exposed reinforcement, were located at the chamfered haunch edges of many locations at both bridges (Figure 11). The spalls were more common along the outer face of the outermost girders, especially at span ends.

significance, so spalling does not present a risk to structural integrity of the bridges. Considering the lack of exposed, corroded reinforcement or significant girder corrosion at the majority of chamfer spalls, the distress is likely related to poor detailing instead of structural overloading or girder corrosion formation.

Figure 11. Typical chamfered haunch spall, with no visible reinforcement.

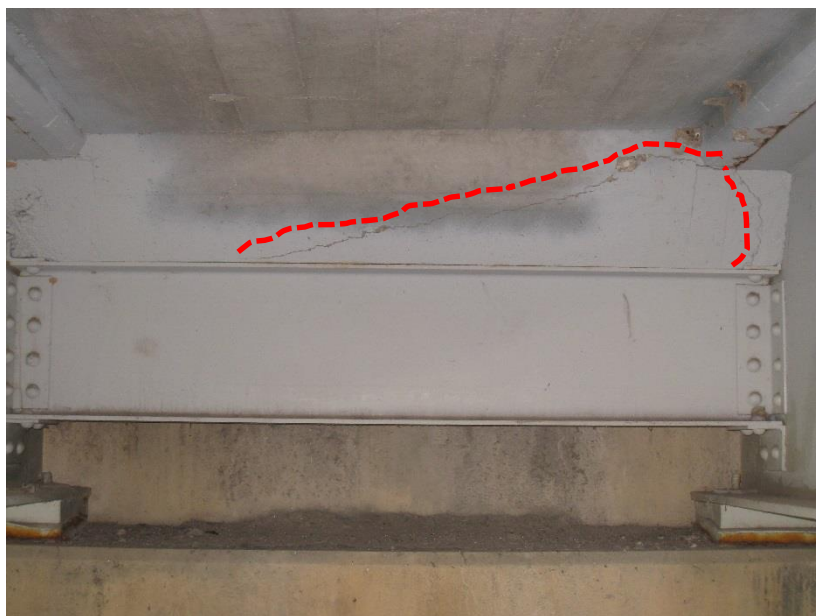
4. The concrete infill at many diaphragms exhibited cracking up to 1/16 inch in width, including at locations exhibiting minimal corrosion formation (Figure 12). The cracking generally originated at reentrant corners formed where the concrete was cast adjacent to girder top flanges. Based on the original construction drawings (Figure 3), the infill contains longitudinal steel reinforcement that terminates near the girder webs and transverse, vertical reinforcement that extends into the deck. Figure 12 was taken on the interior side of the girder shown in Figure 8 and Figure 9.

Crack formation in the concrete infill above steel diaphragms likely resulted from poor detailing of the diaphragms combined with any movement of the steel superstructure relative to the deck. Because the deck does not act compositely with the steel girders, any differential movement of the deck relative to the girders likely induced tension in the infill cast beneath the top girder flange. Crack formation should not significantly affect the compressive load-bearing capability of the concrete infill, and the concrete contributes little to the lateral bracing provided by the steel diaphragms. Therefore, the cracks do not present a risk to the structural integrity of the bridges, although they may create falling debris hazards over time.

Figure 12. Typical cracking of diaphragm concrete, originating at reentrant corner created by girder top flange. Interior diaphragm with minimal corrosion shown.

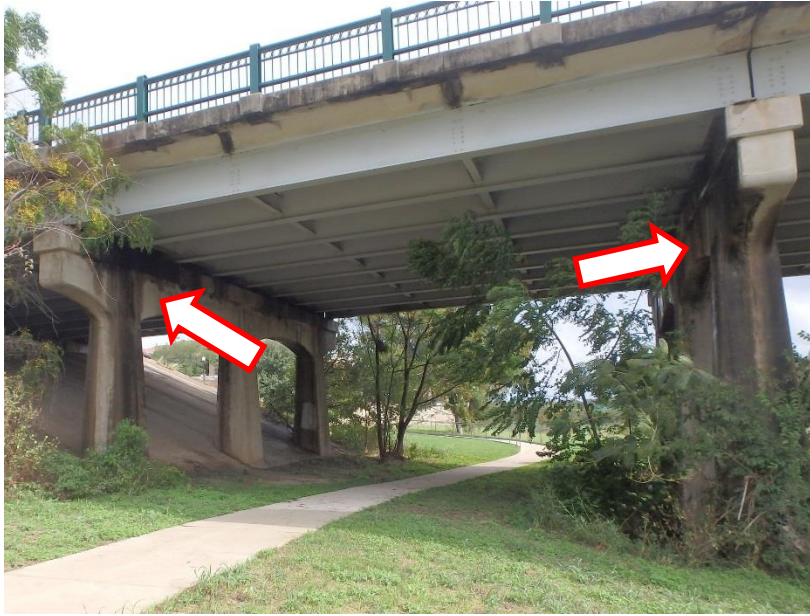
5. During a rain event on November 5th, water leakage from the bridge decks was observed at several piers/bents, especially near the outermost girders (Figure 13). Considering the previous A&F report and based on the widespread extent of the condition, WJE did not identify specific joint leakage locations.

Figure 13. Typical leakage beneath expansion joints, with evidence of persistent moisture staining near exterior bent columns.

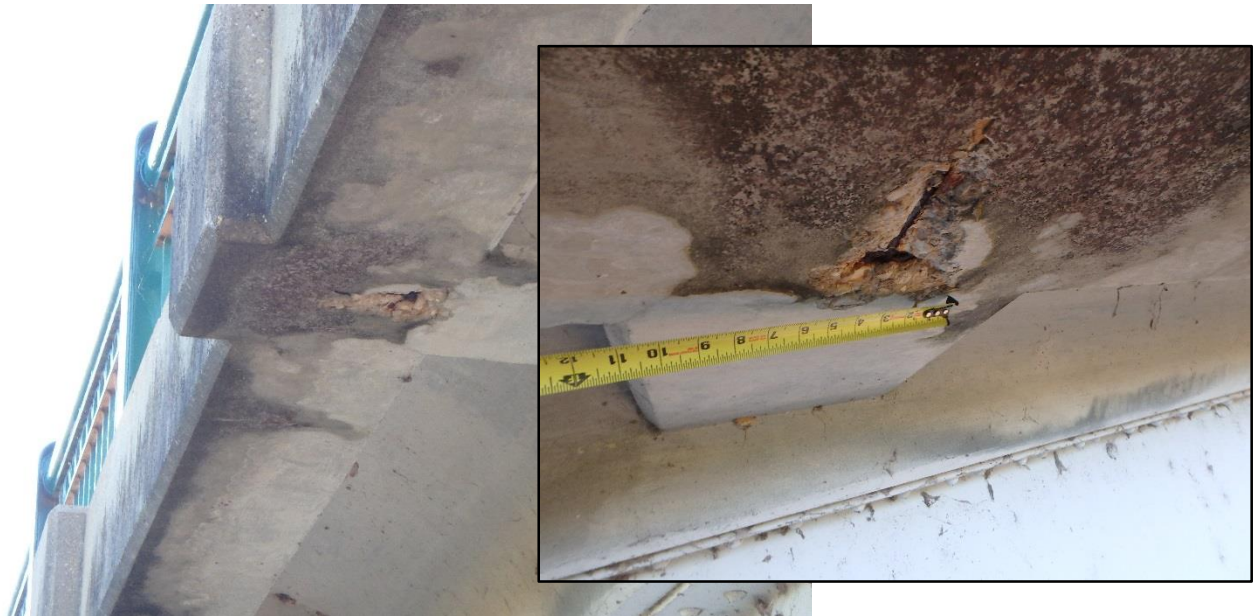
6. Based on review of the original construction drawings, the original pedestrian railings remain in place at the North and South Bridges. Coatings at the pedestrian railings were generally intact, and the railings did not exhibit apparent corrosion or vehicular impact damage. The deck soffit exhibited minor surface

corrosion staining beneath some railing posts, where the posts were cast integrally with the deck. A spall exposing a corroded post base was visible in at least one location (Figure 14).

Figure 14. Typical isolated spall at base of pedestrian rail post, with exposed, corroded post base (northeast side of North Bridge shown).

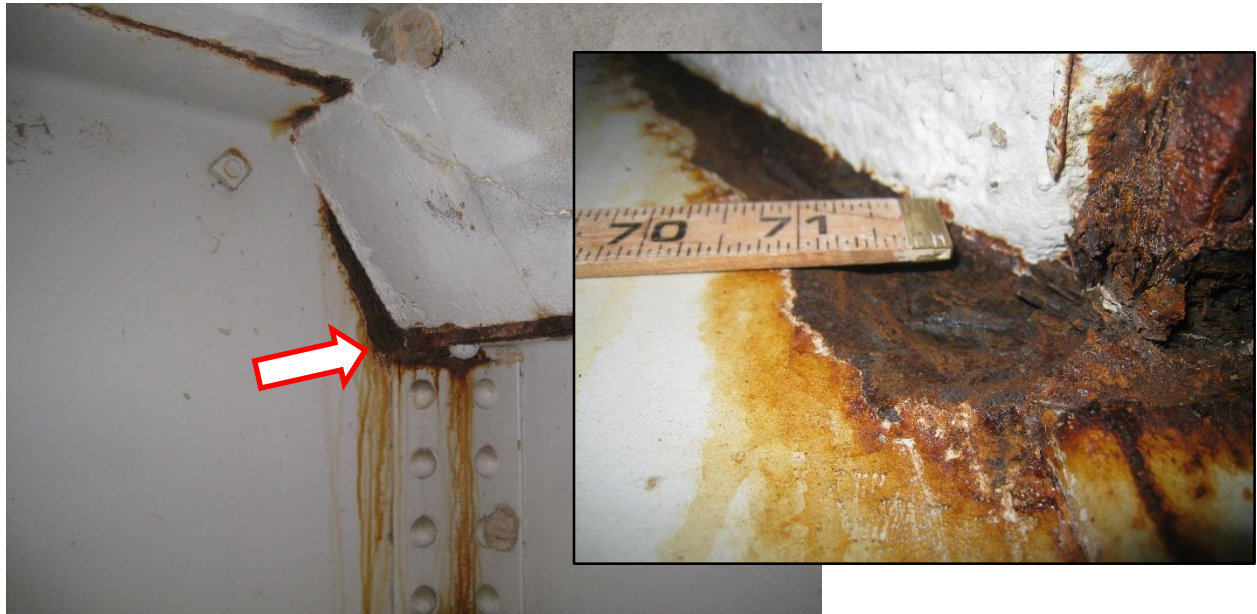
7. Girder webs typically exhibited moderate corrosion section loss near diaphragm connections at exterior girders and minor pitting or surface corrosion at interior diaphragm connections. The corrosion was typically concentrated where concrete diaphragm infill is cast flush with the adjacent girder web (Figure 15). Coatings appeared to have been applied to the girders near the corroded connections, but with limited functionality (paint bubbling or flaking) due to corrosion product expansion.

Girders typically only exhibited measurable corrosive section loss at diaphragm connections. The loss appears to be concentrated at the web, while top and bottom girder flanges typically exhibit little to no surface corrosion. The web section loss is unlikely to present an immediate risk to the structural integrity of the girders, as the corrosion is typically located at regions of relatively small shear demand. However, corrosion of the connections is expected to propagate at an increasing rate due to the moisture retentive nature of corrosion product. Corrosive section loss may create a falling debris hazard unless corrosion is completely removed and a corrosion-inhibiting coating is applied at locations susceptible to corrosion.

Figure 15. Moderate corrosion pitting of girder web at diaphragm connection, where diaphragm concrete is cast flush with steel (web section loss of approximately 1/8 inch). Interior face of outermost girder shown.

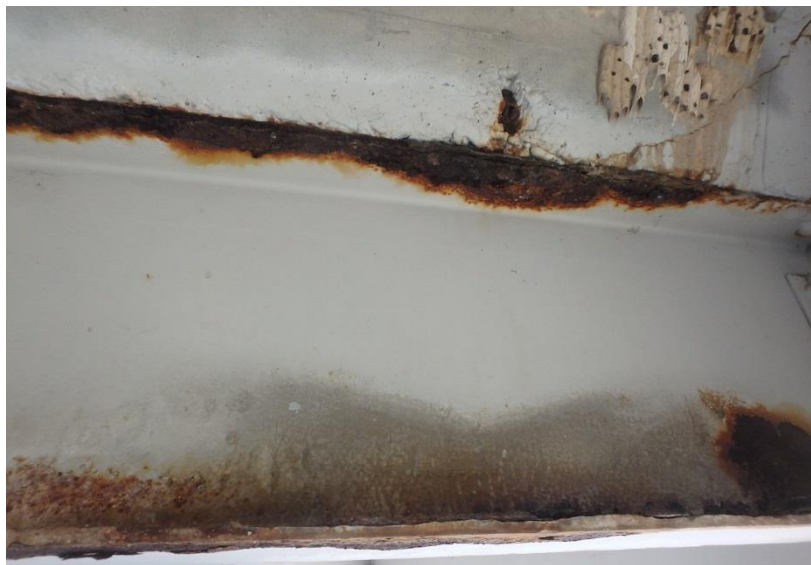
8. Expansive corrosion product appeared to be confined between the concrete infill and diaphragm top flanges between the outermost girders of both bridges, a condition known as “pack rust.” Some diaphragm top flange tips exhibited total corrosion section loss (Figure 16). Diaphragm bottom flanges at these locations typically exhibited minor to moderate corrosion section loss. Interior diaphragms generally exhibited minor corrosion section loss or surface corrosion.

Alignment of construction joints over intermediate diaphragms, and the use of girder and diaphragm top flanges as stay-in-place forms, likely exacerbated the corrosion of the diaphragm top flanges. It is unclear

Figure 16. Typical pack rust formation at diaphragm top flange, with flange tip section loss.

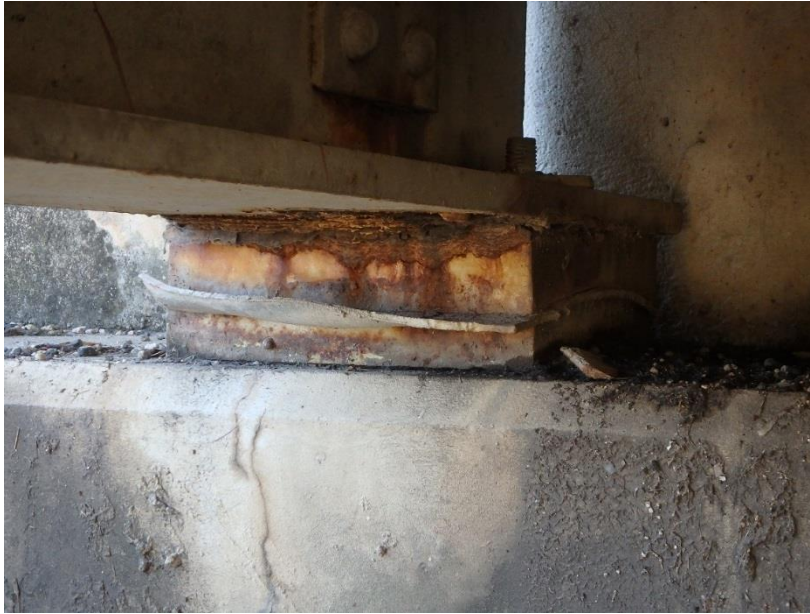
11. Consistent with the A&F report, most steel plate bearings exhibited minor corrosion and deterioration of lead sheets between steel bearing plates (Figure 17). Isolated bearings at exterior girders exhibited moderate corrosion and pack rust (Figure 18).

Corrosion accumulation or lead sheet deterioration in the steel girder bearings likely contributed to the isolated occurrences of concrete substructure spalling by reducing the ease of movement of the steel bearings. Furthermore, as lead sheets within the steel ball-and-socket bearings deteriorate or become partially dislodged, the total thickness of the bearing is reduced, thus potentially resulting in the observed separation of the deck from the girders at the ends of the North Bridge. Deterioration of the lead padding should not present an immediate structural capacity hazard. However, degradation of the lead padding should be expected to continue if not addressed in conjunction with partial-depth concrete bearing repairs and improvement of construction and expansion joint sealants. In current bridge maintenance practice, lead-padded steel bearing assemblies are typically replaced with neoprene bearing pads upon deterioration. Neoprene bearing pads reduce the transmission of dynamic live-load impacts to substructure elements and

Figure 17. Corrosion of outermost bearing assembly, with deterioration/protrusion of lead sheet. Southeast corner of South Bridge shown.

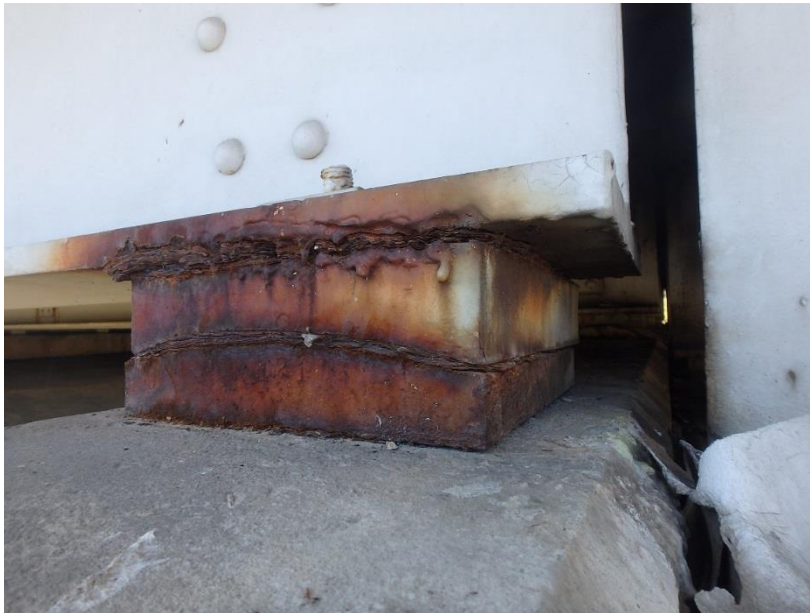
Figure 18. Pack rust formation at outermost bearing exposed to prolonged sidewalk drainage (east side of South Bridge Bent 2 shown).

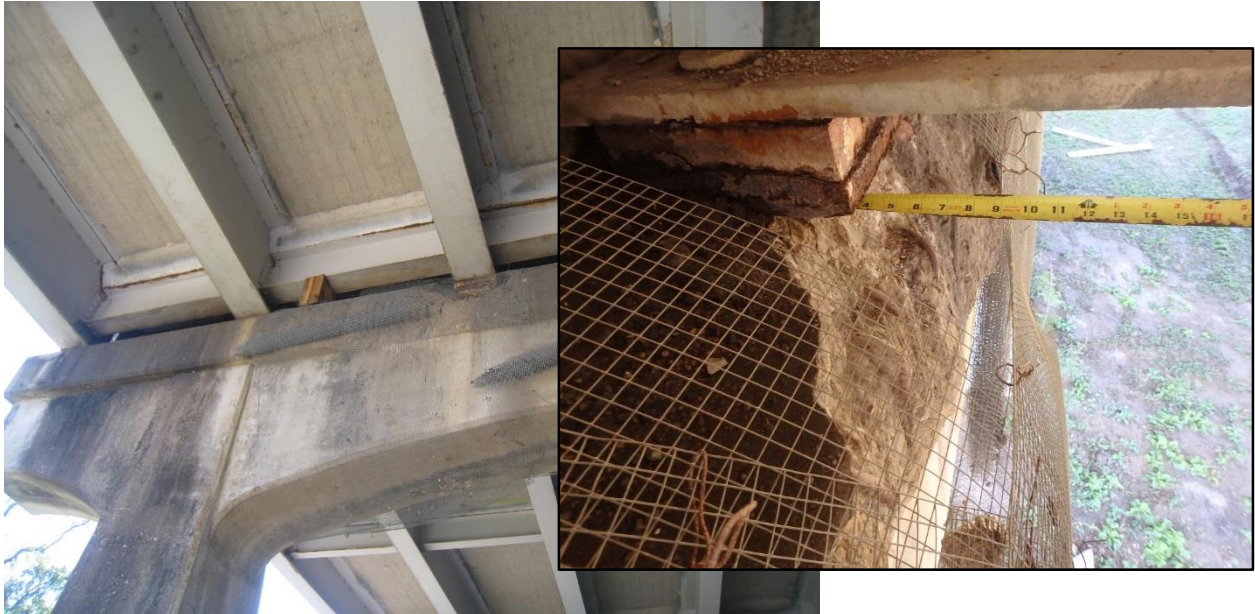
12. The concrete beneath the bearing at South Bridge Bent 2 exhibited a large spall (Figure 19). Intact portions of the spalled concrete exhibited concrete cover of up to 2 inches (Figure 20). A similar, large insipient spall was located at South Bridge Abutment 1 (Figure 21).

Isolated substructure distress near bearing caps is likely related to deterioration of the girder bearings, as previously indicated in the A&F report. Furthermore, the random location of the concrete distress suggests that other defects, such as cracking, randomly shallow reinforcement, or mechanical damage, likely contributed to the observed spalling distress. The observed spalling appears to have predominantly affected the outermost layer of reinforcement—stirrups near the distress—with limited to no deterioration of the longitudinal substructure steel. The bearing capacity of the third girder from the east of South Bridge Span 2 may be affected by the distress, as previously noted by A&F. Considering the distribution of loading through the deck to adjacent girders, the reduced bearing capacity of the girder should not present an immediate structural integrity hazard. However, restoration of that bearing will likely require temporary jacking/shoring of the bridge and partial-depth concrete repair.

Figure 19. Large spall at South Bridge Bent 2.

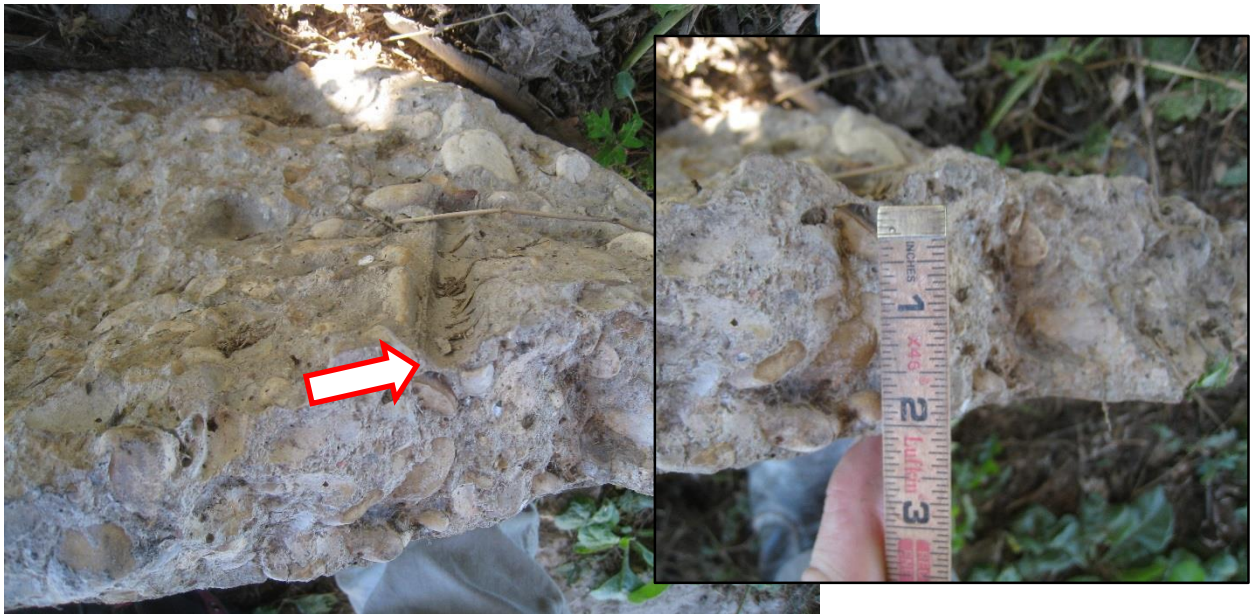
Figure 20. Spall debris from South Bridge Bent 2 spall, exhibiting approximately 2 inches of concrete cover to the reinforcement, based on indentation in debris.

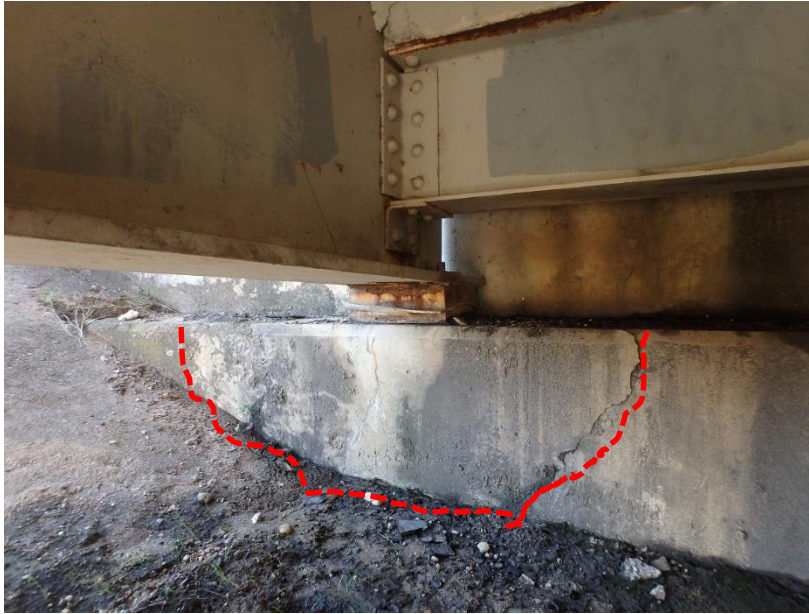
Figure 21. Delamination (insipient spall) at South Bridge Abutment 1, highlighted with red dashed line.

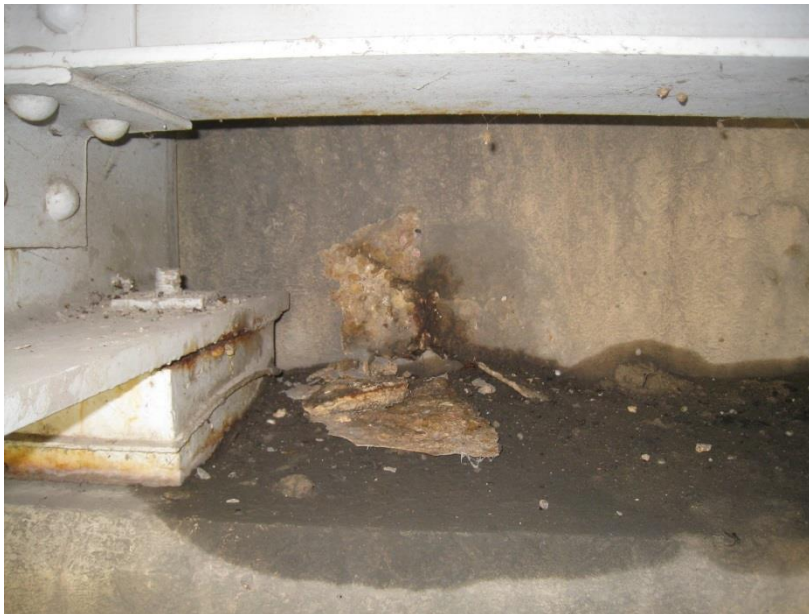
13. Isolated spalls or insipient spalls were identified at abutments, bents, and piers. Such spalls were somewhat more common at abutments than at bents/piers. Some of the spalls exhibited shallow cover over corroded reinforcement (Figure 22 and Figure 23).

Figure 22. Typical isolated spall at abutment back wall, with exposed, corroded reinforcement (South Bridge Abutment 1 shown).

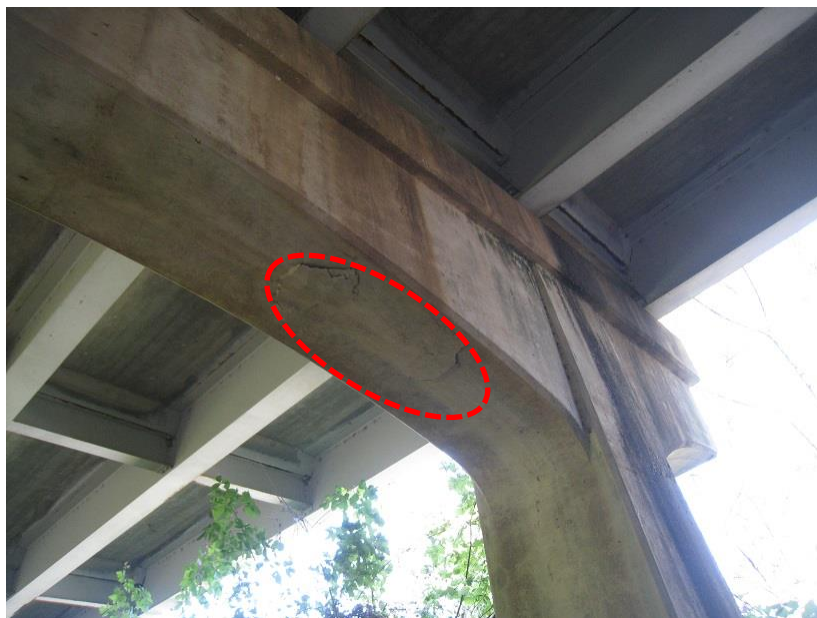
Figure 23. Isolated bent cap soffit spall (North Bridge Bent 2 shown).

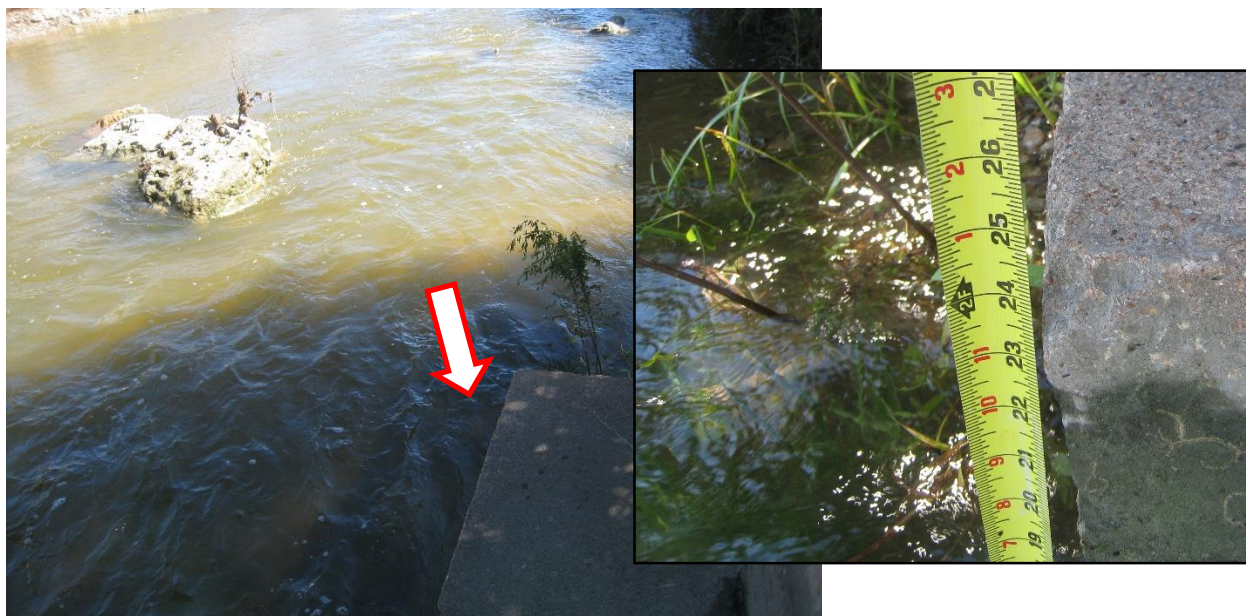
Figure 24. Scour at east end of South Bridge Pier 3, with concentrated water flow due to boulders in San Gabriel River.

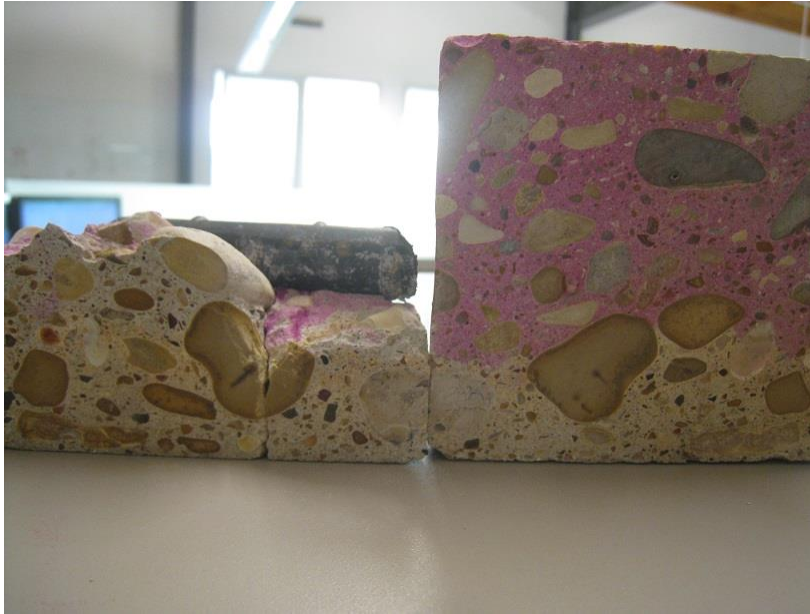
WJE cored through single reinforcing bars in two of the deck cores, Cores 6 and 8 (Figure 31 and Figure 32). Reinforcement in Core 8 exhibited no corrosion, while the reinforcement in Core 6 exhibited minor surface corrosion (Figure 33). Carbonation testing of the two cores indicated that the carbonation front extended to

a depth of 1-1/2 inches in Core 6 and 7/8 inch in Core 8. Concrete cover was approximately 1-1/4 inches in both cores. Section loss of the corroded bar in Core 6 was estimated to be less than 3 mils, which is equivalent to 0.5 percent of the No. 5 bar diameter.

Figure 31. Fractured Core 8, in which the carbonation depth (non-pink region) has not reached the reinforcement, and reinforcement exhibits no corrosion.

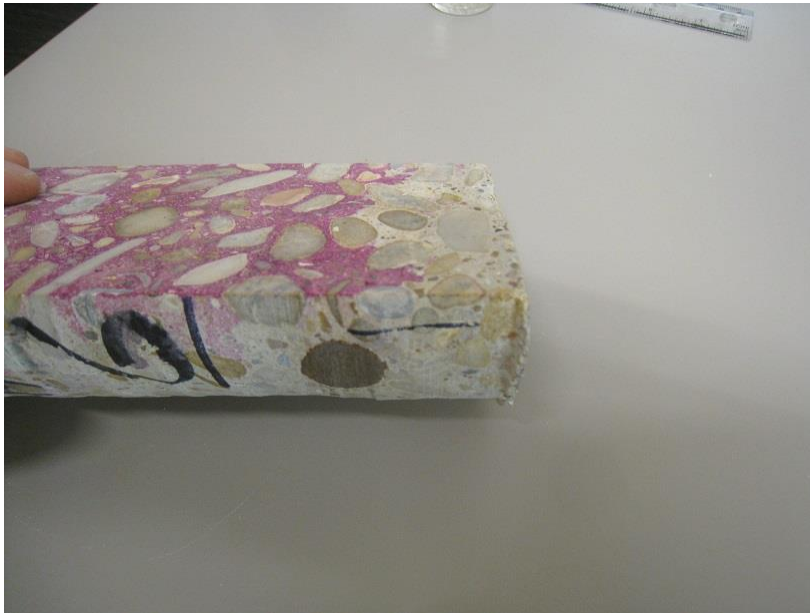
Figure 32. Core 6, with apparent carbonation beyond depth of embedded No. 5 reinforcement.

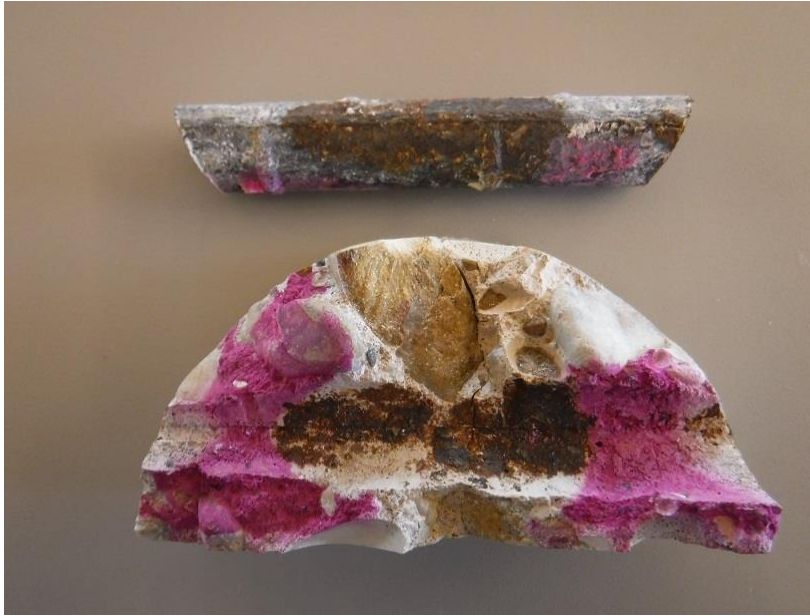
Figure 33. Fractured Core 6, in which reinforcement only exhibits surface corrosion where carbonation depth exceeds concrete cover (non-pink region in middle of core).

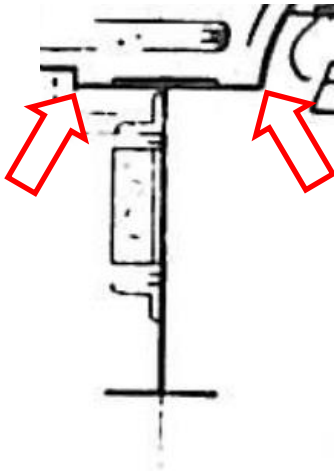
Modern detailing typically avoids creating construction conditions that may induce tension in unreinforced concrete elements. The unreinforced, chamfered edges of concrete haunches cast adjacent to girder top flanges (Figure 36) are subject to tension as a result of thermal or load-induced deck movement or expansive corrosion of the outer edge of the top girder flange. Spalling of the unreinforced concrete toe is likely in such circumstances, even if the concrete material is sound. Still, the chamfered toe has minimal structural

Figure 36. Unreinforced regions of haunch chamfers (arrows), susceptible to spalling due to detailing.
