June 29, 2016

Re: Austin Avenue Bridges at the San Gabriel River Assessment

Per your request, on March 21, 2016, Lockwood, Andrews & Newnam (LAN), Inc. conducted a site visit of the North and South Austin Avenue Bridges located at the San Gabriel River in Georgetown, TX. In addition to our site visit, LAN was provided and reviewed the following:

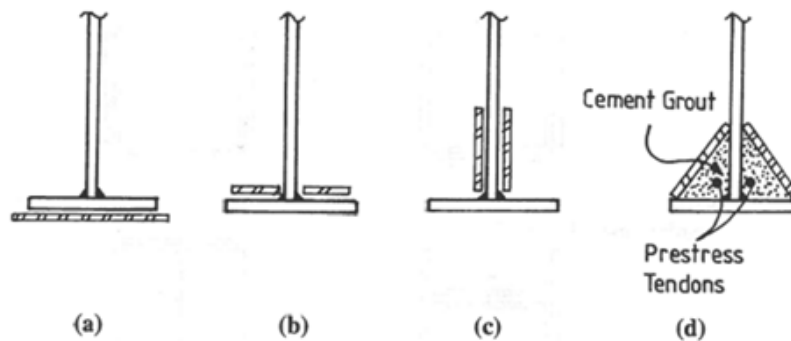
Figure 5. Strengthening Options for a Steel Bottom Flange:
(a) and (b) horizontal plates, (c) two vertical plates, (d) prestress tendons

1. Deck Replacement: Partially replacing the existing non-composite deck with a composite deck (i.e.; Spans 2-4 South Bridge and Spans 4-6 North Bridge) will increase the superstructure's load rating, Condition Rating and Service Life. This would require a phased construction which will impact traffic significantly during construction.
2. Strengthen Critical Section: An alternative option with minimal traffic impact is strengthening the critical section (i.e.; Span 3 South Bridge and Span 5 North Bridge) by modifying the load path or by adding material. This can be achieved with the addition of plates or prestress tendons to the steel beams (See Figure 5).

Two alternatives could be used to strengthen the superstructure above an Inventory Rating of HS20.

Option 1	Option 2*
Inventory Rating	HS 29.6	HS 20.6
Operating Rating	HS 49.4	HS 34.3

*Assumes 1/2" horizontal plates are added to critical section
