Austin Avenue Bridges Project – Walking Tour

Agenda

AUSTIN AVENUE BRIDGES PROJECT
GEORGETOWN, TEXAS

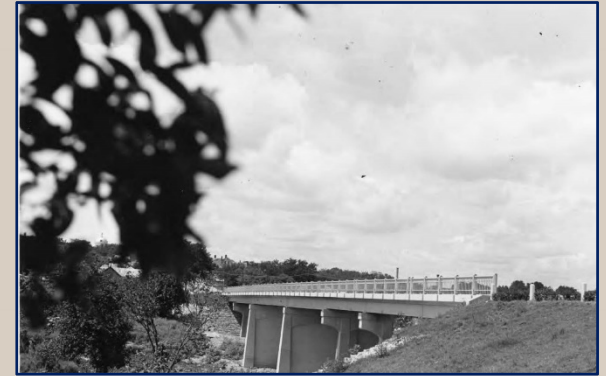
Texas. Department of Transportation. [South San Gabriel River Bridge on U.S. Highway 81]. Photograph, July 9, 1940; (<http://texashistory.unt.edu/ark:/67531/metapth167288/>; accessed March 16, 2016).

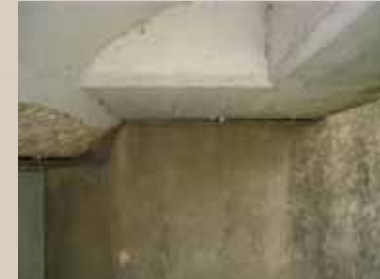
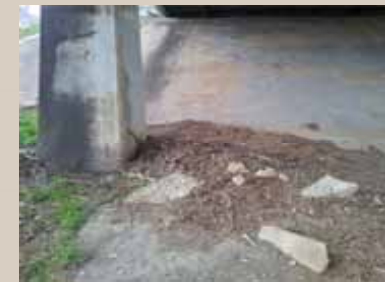
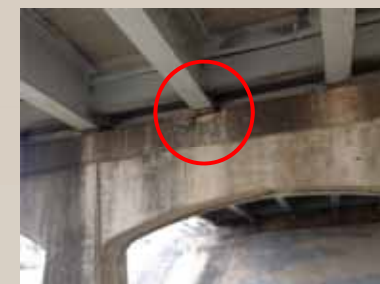
- Bridge is 76 years old and typical design life is 75 years
- Bearings (what the beams sit on) have deteriorated.
 - The bearings are “locked up” and do not currently allow the bridge to “breathe” (expand, contract), causing spalling at joints
- Steel beams have corroded/rusted over time due to exposure to water coming through the deck joints. Top of beams under deck
- Based on inspections, load restricted to 48,000 lbs (garbage trucks, 18 wheelers)
 - No enforcement and heavy loads accelerate deterioration but do not pose imminent danger
- Maintenance to date includes: hardware cloth wraps, remediate lead and repaint, oak bearing blocks (6m), joint patches and curb repairs (above)

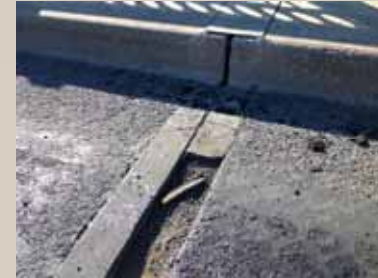
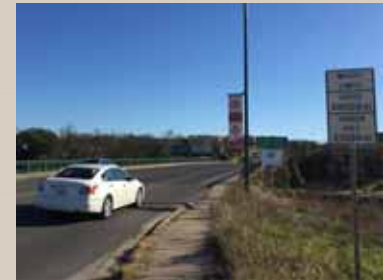
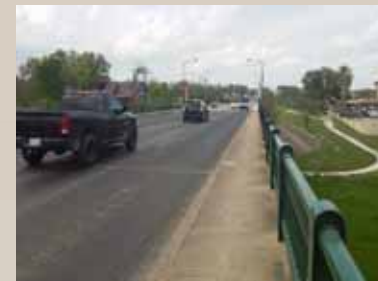
- Roadway classified as a Principal Arterial with an AADT of 13-19k
- Current lane width is 11', desirable is 12'
- Sidewalk width 4' min, 6' desirable, 5' min for wheelchair w/companion or 2 side by side, 8-10' for shared used (bike/ped)
- Lacking a 2' minimum offset from the edge of travel way to pedestrian elements (consider traffic above and a 2015 growth rate of 6.8%)
- City has covered sidewalk joints - no opening larger than 0.5" dia (walkers, crutches, etc), perpendicular to travel
- Curb and joint fragments create a hazard to vehicles and pedestrians
- Railing is not to current ADA or crash standards
- Today's needs are not met - no reliable trail connections to N and S San Gabriel
