AUSTIN AVENUE BRIDGES PROJECT
GEORGETOWN, TEXAS

Austin Avenue Bridges Project

AUSTIN AVENUE BRIDGES PROJECT – WALKING TOUR

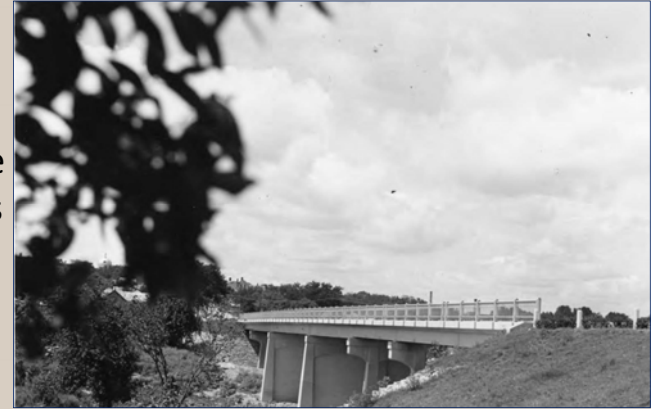
- 1940** Construction of bridges is completed, Cantilevered-suspended span configuration, advantage of configuration was that it enabled bridge to have significantly longer span and thinner deck, reducing the number of supports needed

Texas. Department of Transportation. [South San Gabriel River Bridge on U.S. Highway 81], Photograph, July 9, 1940; (<http://texashistory.unt.edu/ark:/67531/metaph167288/>; accessed March 16, 2016).

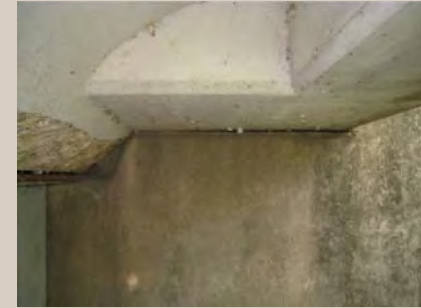
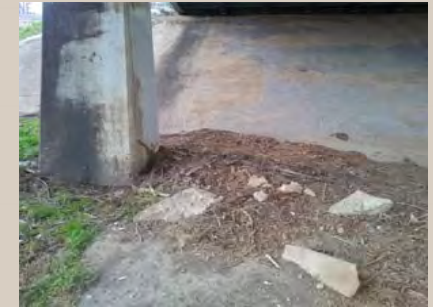
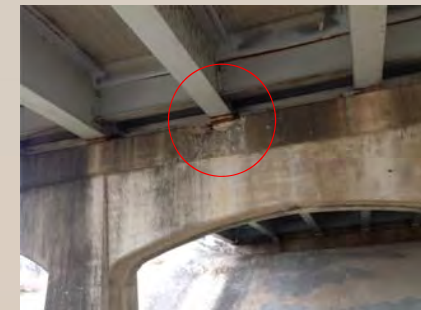
Structurally Deficient

- Bridge is 76 years old and typical design life is 75 years
- Bearings (what the beams sit on) have deteriorated.
 - The bearings are “locked up” and do not currently allow the bridge to “breathe” (expand, contract), causing spalling at joints
- Steel beams have corroded/rusted over time due to exposure to water coming through the deck joints. Top of beams under deck
- Based on inspections, Load restricted to 48,000 lbs (garbage trucks, 18 wheelers),
 - No enforcement and heavy loads accelerate deterioration but do not pose imminent danger
- Maintenance to date includes: hardware cloth wraps, remediate lead and repaint, oak bearing blocks (6m), joint patches and curb repairs (above)

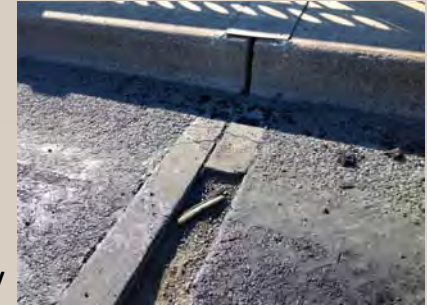
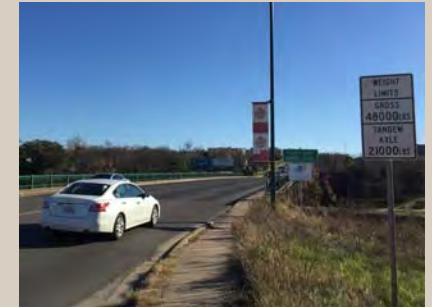
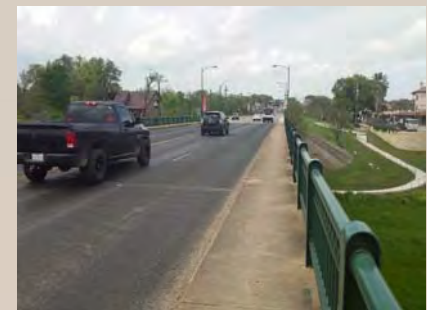
Functionally Obsolete / Safety

- Roadway classified as a Principal Arterial with an AADT of 13-19k
- Current lane width is 11', desirable is 12'
- Sidewalk width 4' min, 6' desirable, 5' min for wheel chair w/companion or 2 side by side, 8-10' for shared used (bike/ped)
- Lacking a 2' minimum offset from the edge of travel way to pedestrian elements (consider traffic above and a 2015 growth rate of 6.8%)
- City has covered sidewalk joints - No opening pass 0.5" dia (walkers, crutches, etc), perp to travel
- Curb and joint fragments create a hazard to vehicles and pedestrians
- Railing is not to current ADA or crash standards
- Today's needs are not met - no reliable trail connections to N and S San Gabriel
