Williams Drive Study - Challenges & Recommendations

Traffic Operations & Safety

Access Management

Driveway Consolidation

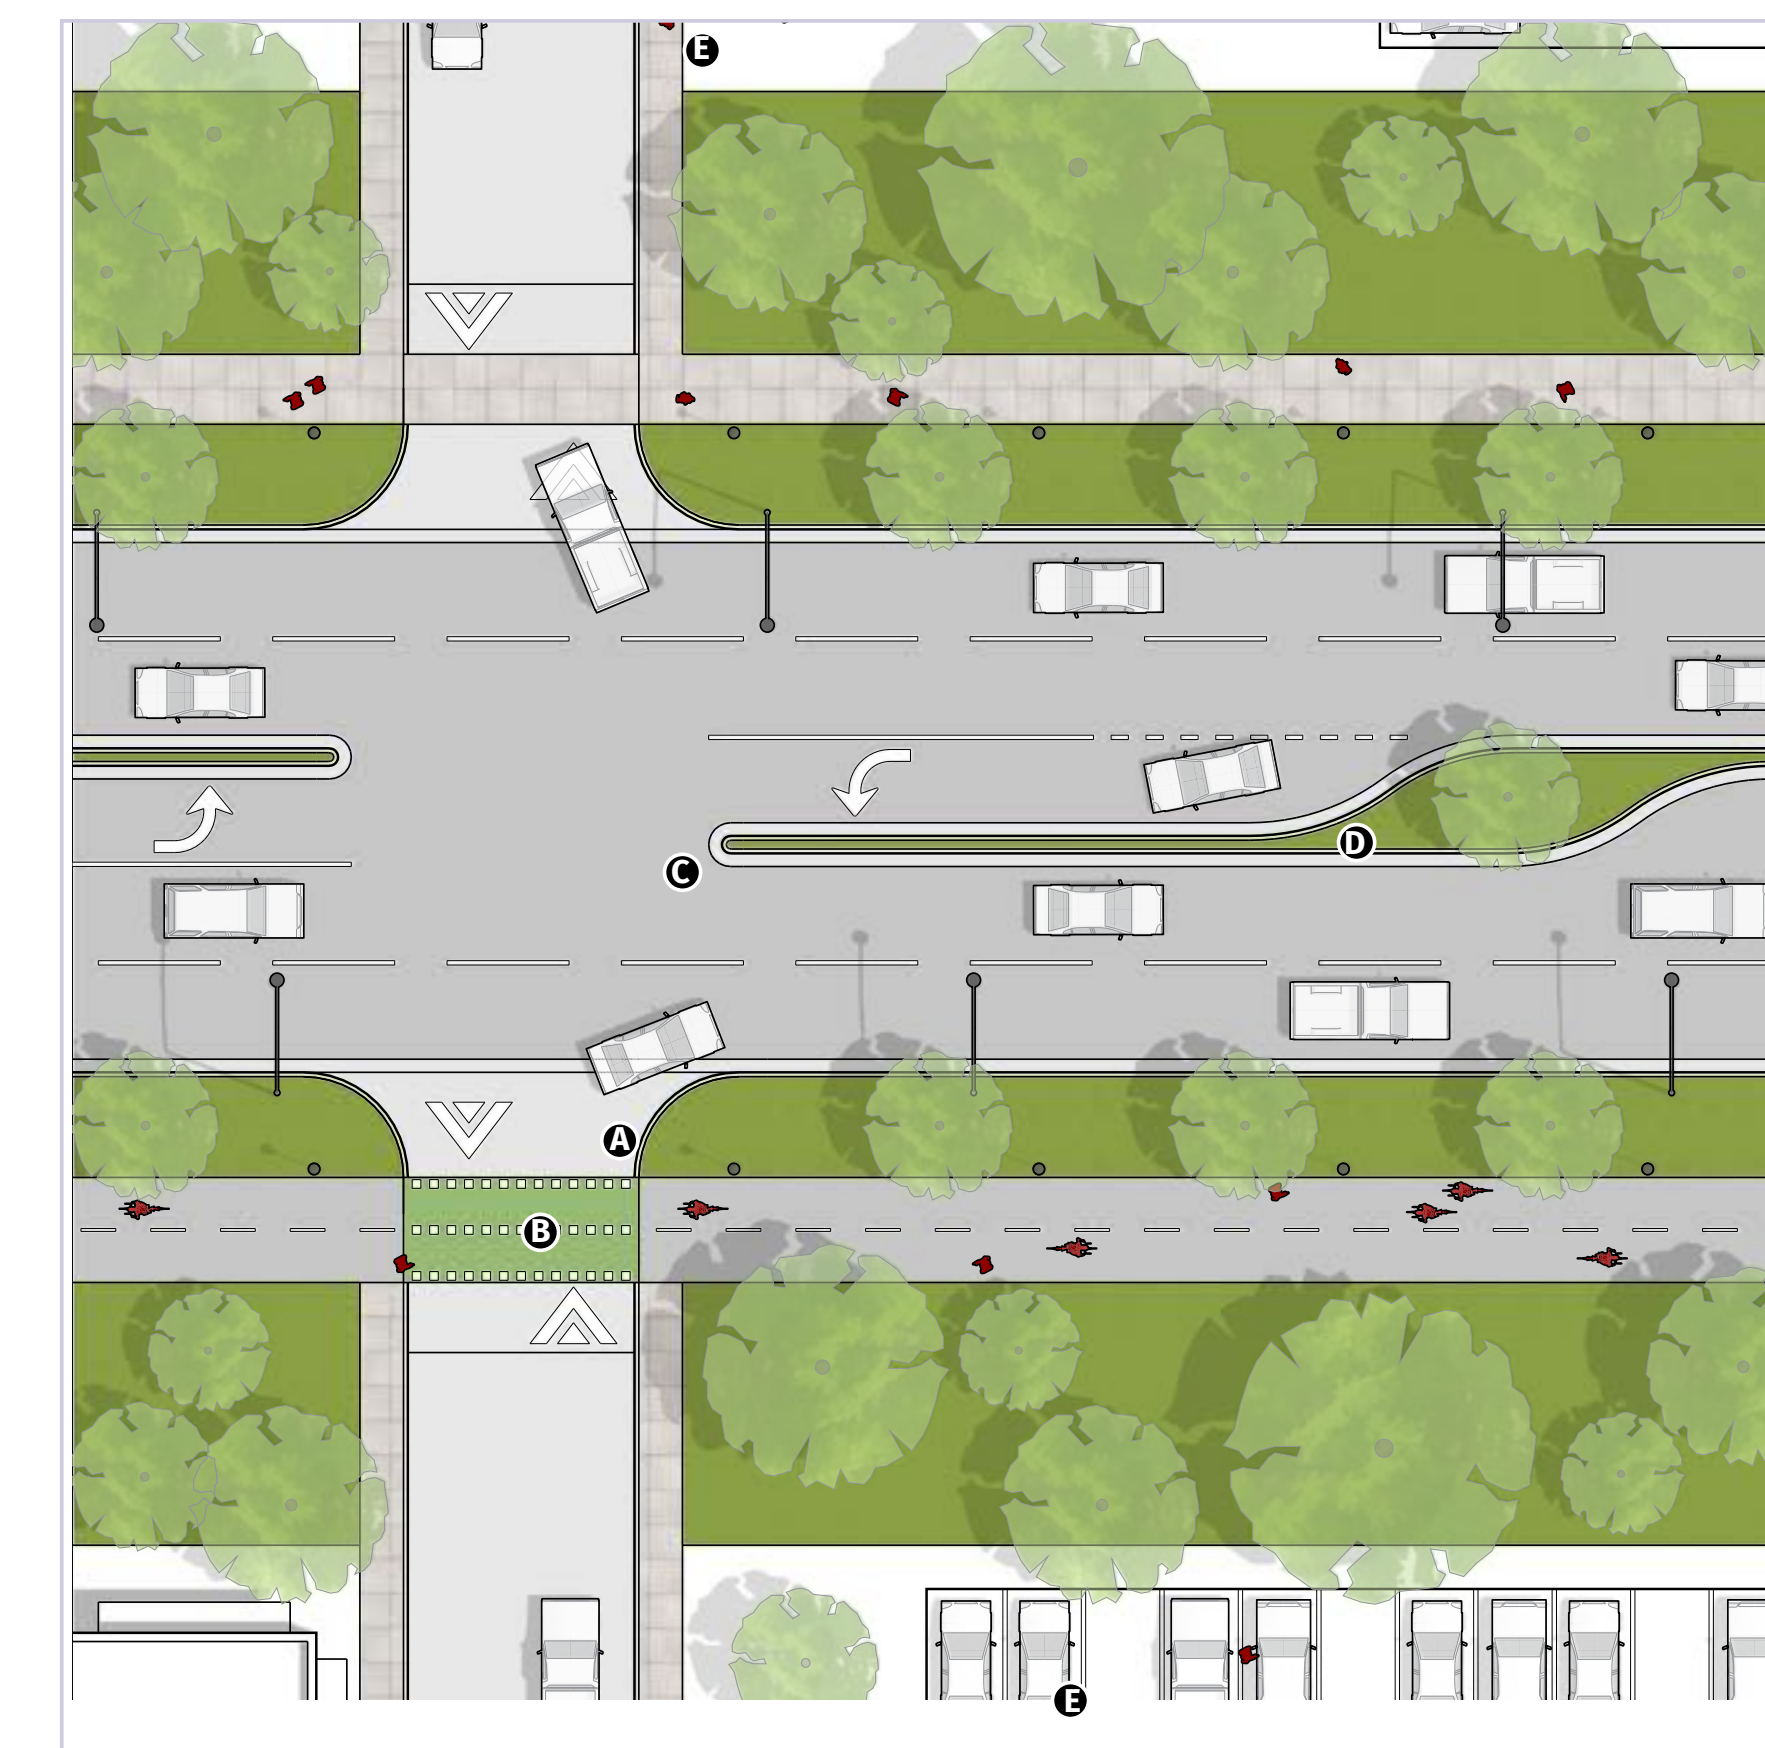
- A** Existing curb cuts consolidated and reduced. Adjacent parking and circulation areas are linked away from Williams Drive.
- B** Side path at grade, materials carried across driveway to reinforce visual cues that pedestrians and cyclists have right-of-way.
- C** To maintain traffic flow, new medians include left turn lanes at major intersections and key driveways.
- D** Stormwater management features incorporated into center medians.
- E** Shared parking lot serves multiple destinations. Destinations either share patrons, so that people park once and visit multiple destinations, or have different periods when parking demand is highest.
- F** Parking located at the rear of buildings where appropriate contributes to increased aesthetic appeal of the corridor.
