WILLIAMS DRIVE MOBILITY ENHANCEMENTS

**Existing Conditions Analysis
Final**

008261
v03
August 2023

EXISTING CONDITIONS ANALYSIS REPORT

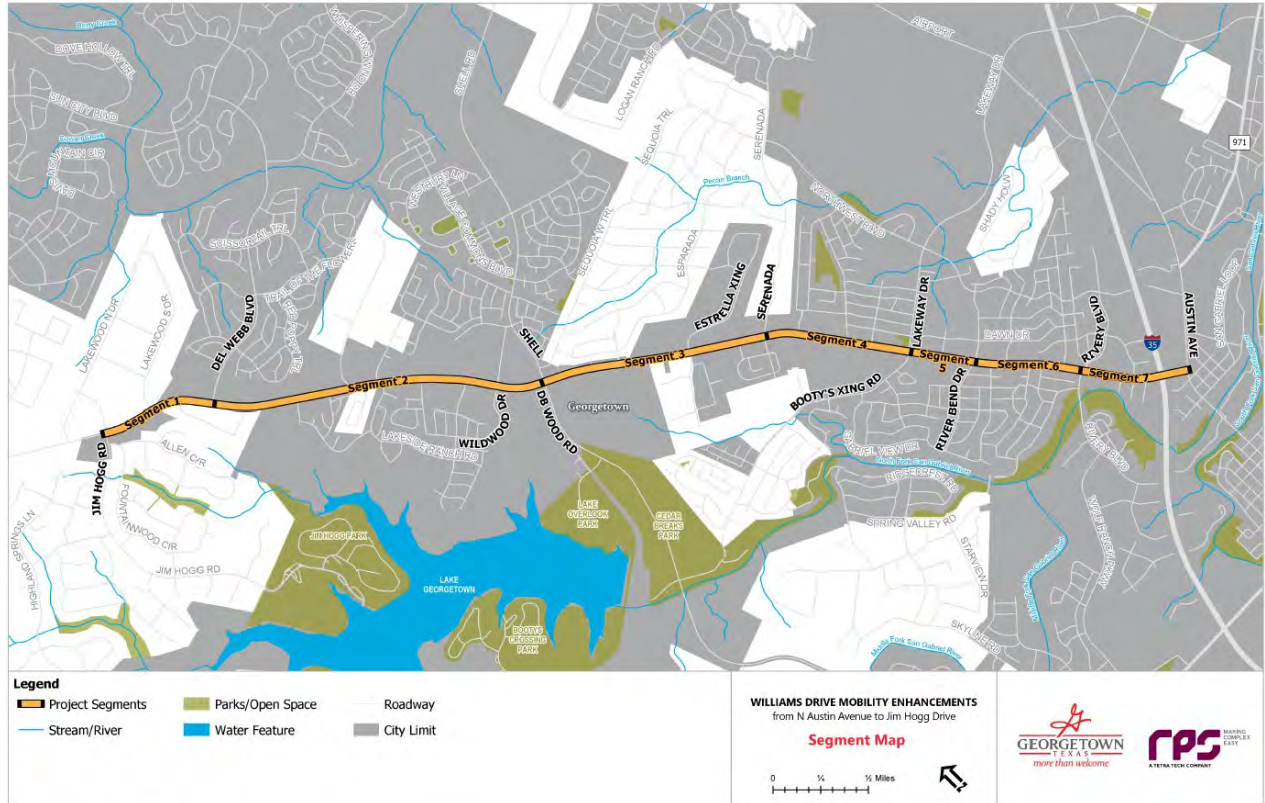
Figure 9 – Williams Drive Segment Map

The existing driveways along the study area were mapped and analyzed. The results are summarized in **Table 3**. The results reveal a total of 148 driveways along Williams Drive from Jim Hogg Road to Austin Avenue. Segment 1 near the western end of the corridor contains the lowest number of driveways, with a total of 11. Segment 6 near the eastern end of the corridor contains the highest number of driveways, with a total of 31. A map of the existing corridor segments is shown in **Figure 9**, while a map of the existing driveway density per segment is illustrated in **Figure 10**.

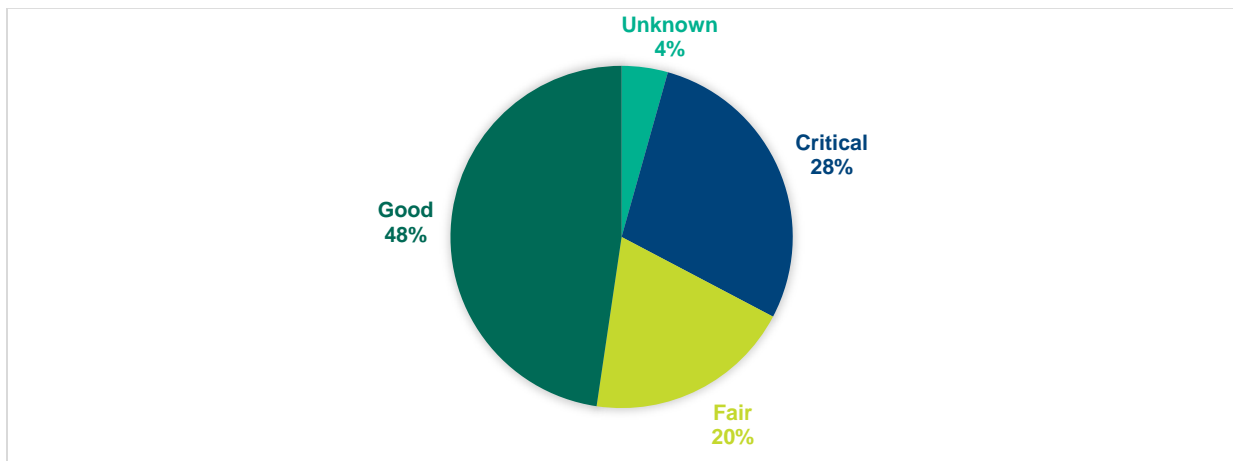
Figure 11 – Roadway Signage Conditions

A breakdown of the conditions of the roadway signage is presented in **Figure 11**. There are a total of 321 signs along the length of the corridor of which 48% are in good condition, 28% are in critical condition, 20% are in fair condition, and 4% are unknown.

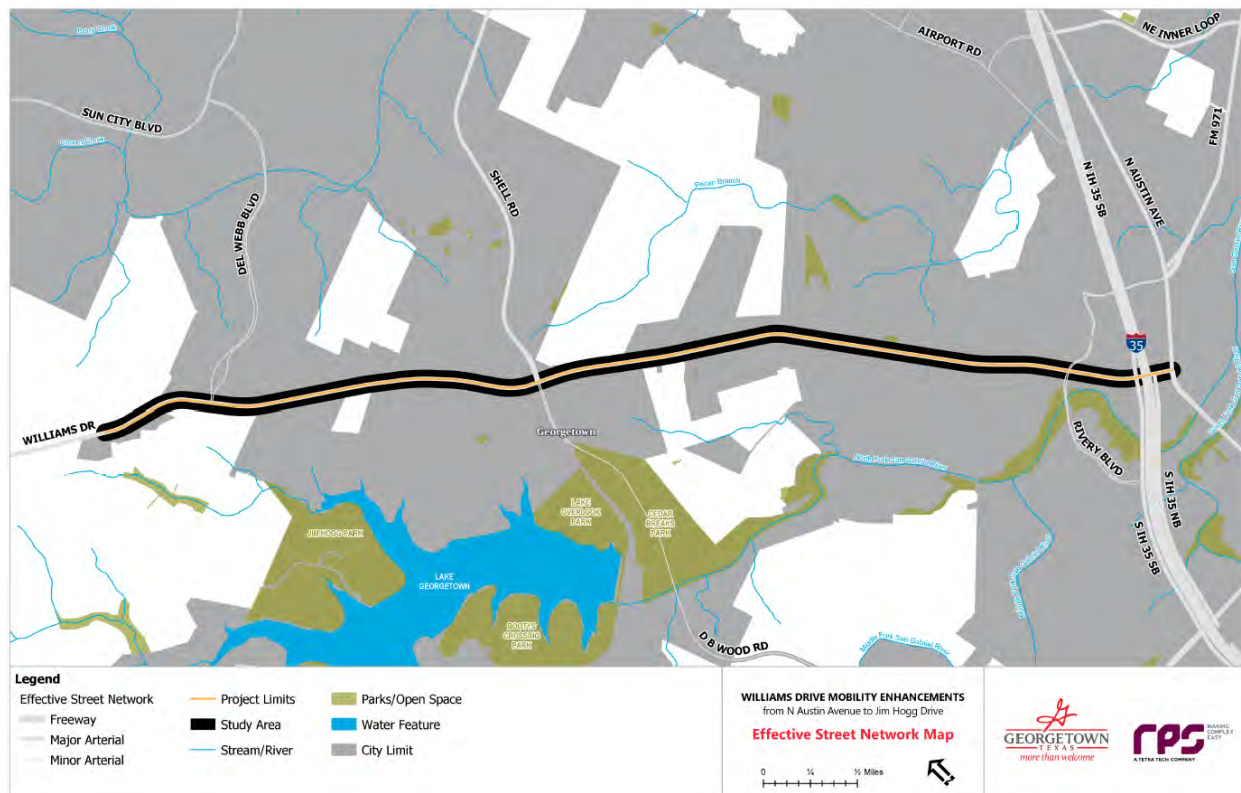
Figure 38 – Effective Street Network Map

A roadway connectivity analysis was conducted along the study area using information from the 2017 Williams Drive Study and 2030 Comprehensive Plan. A roadway connectivity analysis evaluates the interconnectedness and efficiency of the roadway network to identify the overall mobility and accessibility of the area. The effective street network map as shown in **Figure 38** illustrates the key roadways that provide important connectivity throughout the study area. To identify the effective street network, roadways such as dead-end, cul-de-sac, and other disconnected roads were removed from the map. The analysis highlights key roadways such as Williams Drive, Del Web Blvd, Shell Rd/DB Wood Rd, Rivery Blvd, I-35, and Austin Ave, emphasizing the importance of preserving and enhancing access to these routes for improved connectivity in the study area.
