AUSTIN AVENUE BRIDGES AT SAN GABRIEL RIVER Condition Assessment and Evaluation

Georgetown, Texas 78626

Final Report

WJE No. 2015.5402

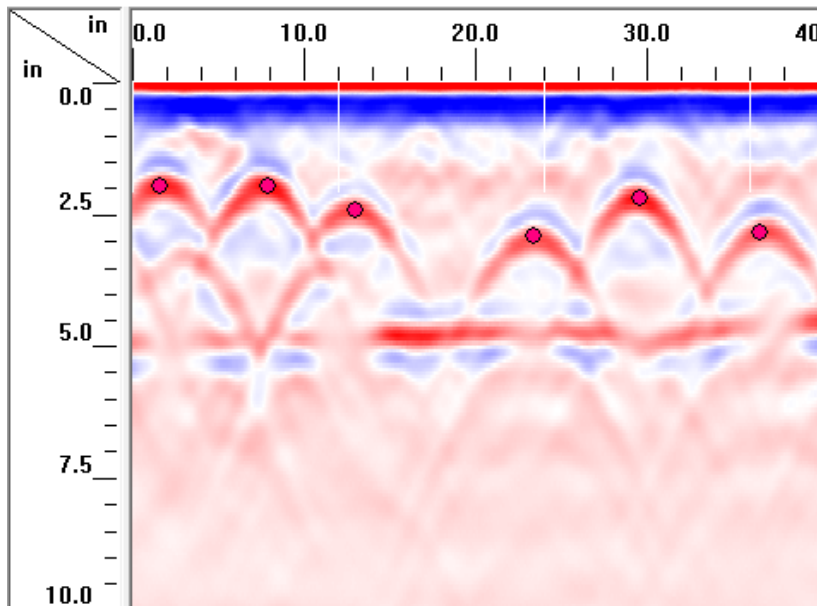
The reinforcement locations and cover depths were recorded using GPR in the field and processed using software licensed from the GPR manufacturer (Figure 25). For comparison, Figure 26 illustrates the distribution of cover from all scans of the deck soffit. To calibrate and confirm the GPR results, cover depth was measured directly by drilling into the concrete at discrete bar locations. Table 1 summarizes the results of our limited GPR cover depth assessment. In the table, cover depths are combined for the two bridges, as cover depths were generally consistent. In general, reinforcement spacing corresponded to details shown in the original construction drawings or was narrower than that shown in the drawings. Based on observations of reinforcement exposed by spalls, as well as two samples obtained from the bridge deck, reinforcement appeared to be of the size shown in the original construction drawings.

Figure 25. Example recorded scan of reinforcement in bent column, with red markers indicating cover depths to reinforcement.

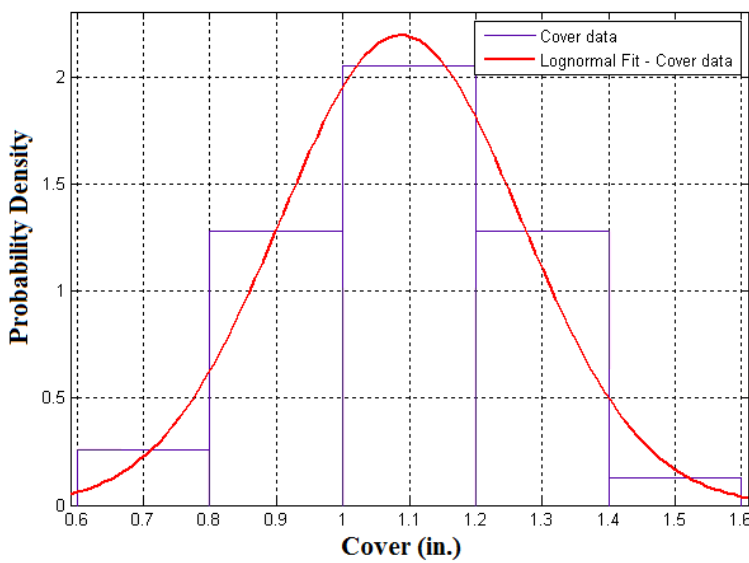
Table 5 summarizes the model input parameters utilized in the Austin Avenue Bridges service life models. The distribution for concrete cover was modeled based on the depths measured by GPR scans in the field (Figure 26). A lognormal distribution was used, since this type of distribution reasonably described the data set and is well suited to describing datasets in which values are close to but greater than zero. An equivalent cover was defined within the model, using the centroid of the semi-circular arc for the near-surface half of the bar, to account for the time elapsed between when the carbonation front passes from the leading edge to the center of the bar.

Figure 26. Distribution of deck soffit cover measurements obtained using GPR equipment.

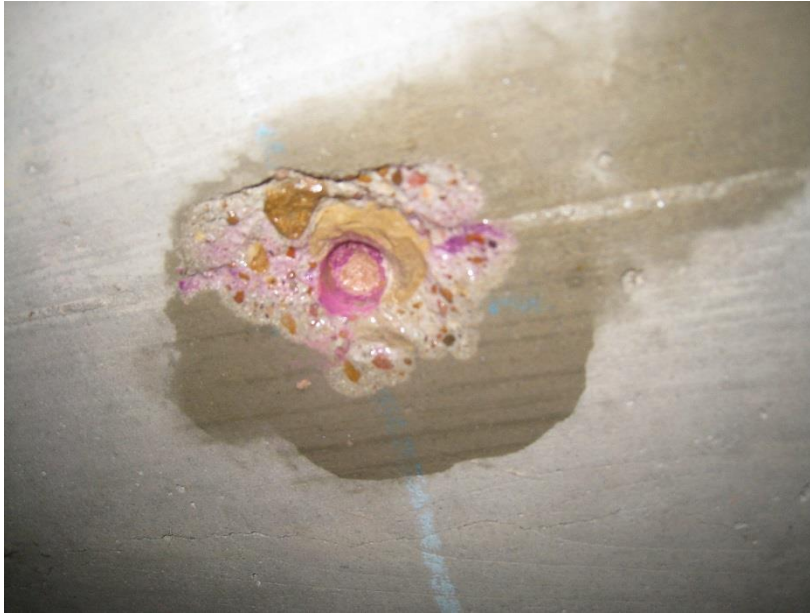
Figure 27. Typical carbonation testing using phenolphthalein solution (pink hue indicates high pH, while lack of color indicates carbonation).

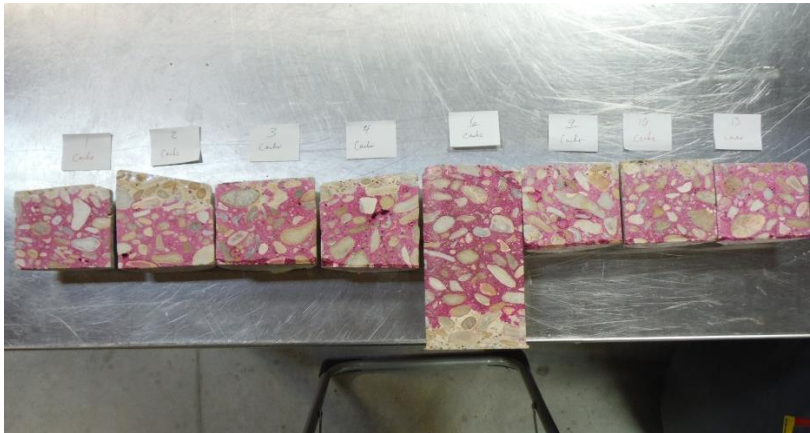
Figure 34. Laboratory investigation of carbonation depth, utilizing phenolphthalein carbonation indicator.

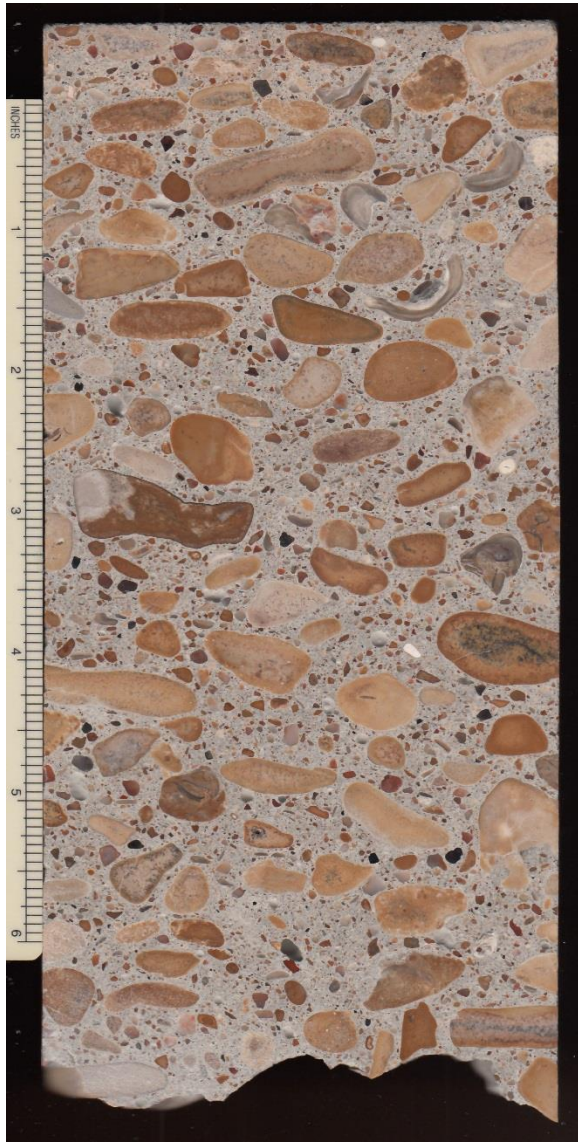
Figure 35. Polished surface of Core 14, scanned for petrographic analysis (outer surface of core at top of scan).

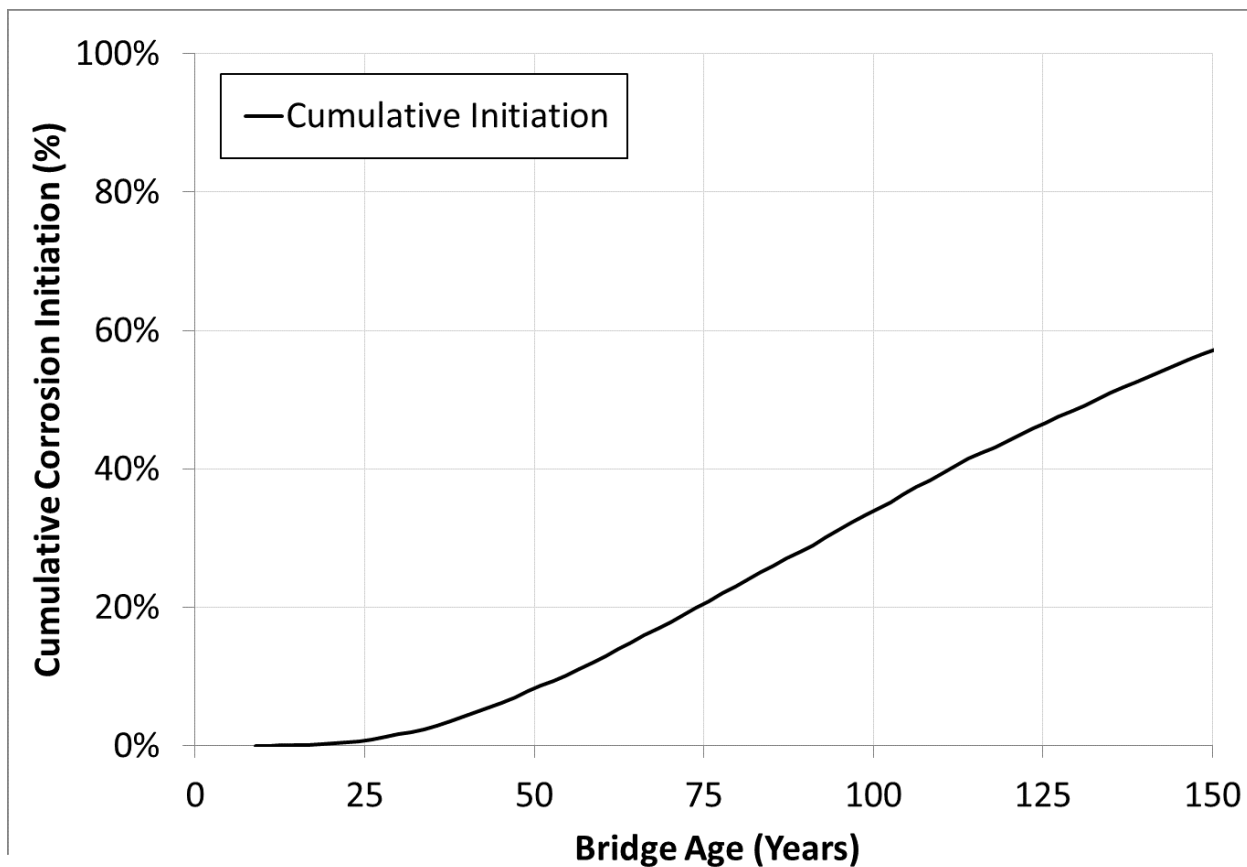
Based on measured carbonation rates and concrete cover depths, the carbonation front has likely reached approximately 20 percent of the deck soffit bottom reinforcement layer (Figure 39). Even if future carbonation-induced corrosion propagation is relatively gradual, the extent of carbonation is significant and is likely to limit the future service life of the decks, unless mitigation strategies are implemented. As previously discussed, damage from carbonation-induced corrosion can be difficult to predict considering the limited amount of visible damage and relatively limited destructive testing of corroded reinforcement conducted by WJE. Figure 40 presents time to damage formation, assuming corrosion rates associated with relatively rapid (higher RH) and gradual (lower RH) corrosion rates derived from the literature.

Figure 39. Cumulative estimate of carbonation-induced corrosion initiation, representing percentage of reinforcement likely embedded in carbonated concrete (approximately 20 percent at age = 75 years).

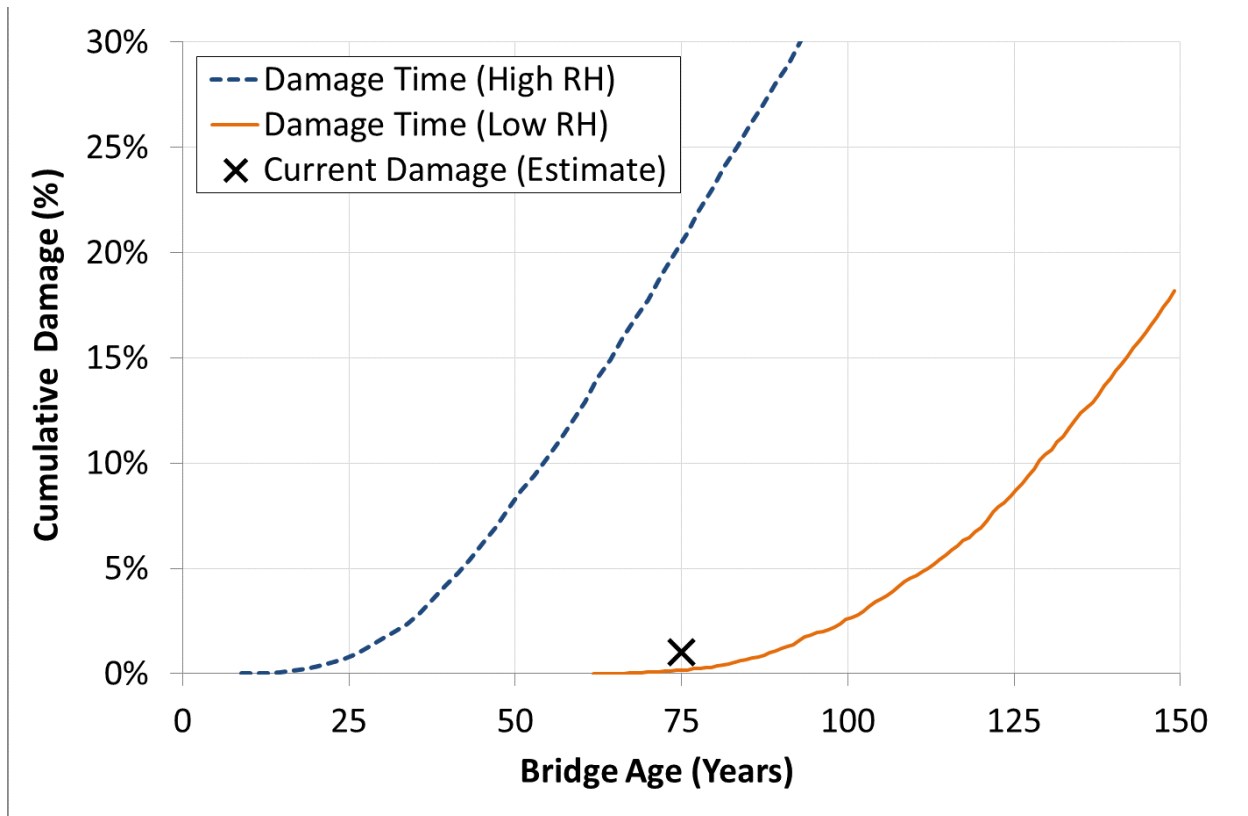
Figure 40 illustrates that, at a relatively high RH of approximately 90 percent, internal corrosion propagation at carbonated concrete regions would likely have already resulted in relatively broad surface

Figure 40. Estimates of cumulative visible soffit damage, based on corrosion rates from the literature.
